DEPARTMENT OF TRANSPORTATION

Quality Assurance and Source Inspection

Contract #: 04-0120F4Cty: SF/ALA Rte: 80 PM: 13.2/13.9File #: 1.28**WELDING INSPECTION REPORT****Resident Engineer:**Siegenthaler, Peter**Address:** 333 Burma Road**City:** Oakland, CA 94607**Report No:** WIR-023962**Date Inspected:** 24-May-2011**Project Name:** SAS Superstructure**OSM Arrival Time:** 700**Prime Contractor:** American Bridge/Fluor Enterprises, a JV**OSM Departure Time:** 1630**Contractor:** American Bridge/Fluor Enterprises, a JV**Location:** Job Site**CWI Name:** Pat Swain**CWI Present:** Yes No**Inspected CWI report:** Yes No N/A**Rod Oven in Use:** Yes No N/A**Electrode to specification:** Yes No N/A**Weld Procedures Followed:** Yes No N/A**Qualified Welders:** Yes No N/A**Verified Joint Fit-up:** Yes No N/A**Approved Drawings:** Yes No N/A**Approved WPS:** Yes No N/A**Delayed / Cancelled:** Yes No N/A**Bridge No:** 34-0006**Component:** Tower**Summary of Items Observed:**

WELDING INSPECTION REPORT

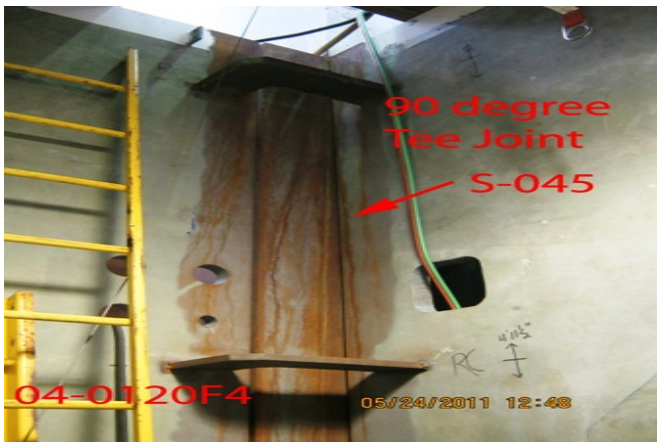
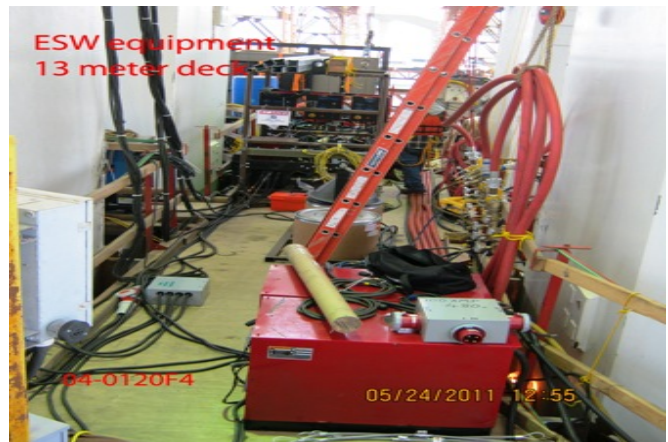
This QA Inspector observed ABF welding personnel Rory Hogan (#3186), Jeremy Dolman (#5042) and others setting up the Electro Slag Welding (ESW) equipment on the deck at the 13 meter elevation. This QA Inspector observed ABF welding personnel Rory Hogan (#3186) and Jeremy Dolman (#5042) were in the process of fitting up and welding various brackets for ladders and equipment at elevations 3, 9 and 13 in preparation to start the ESW. This QA Inspector observed the ladders and channels appeared to be set up on the West side of the weld joint identified as S-045. Both welding personnel stated ESW would not be started this date when asked by this QA Inspector. See various photos of ESW set up below.
